**Flood Control Project Maintenance
Levee Inspections**

Fall 2018 Levee Maintenance Deficiency Summary Report

**Flood Control Project Maintenance
Levee Inspections**
LMA District Cover Sheet
Fall 2018 Levee Inspection Results

Sutter Maintenance Yard Tisdale Bypass

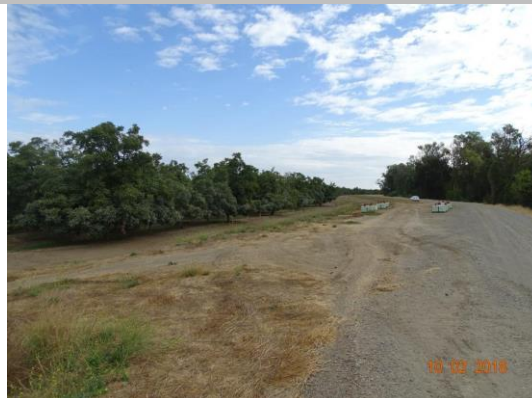
Photo 1 of 1 : FA_2018_ST0009_286_11_20181008_00019.jpg

LM Start	0.02	Rating **	A	Issue No.	11
LM End	0.71	Issue Type +	Ma	Location *	LS
Category	Earthen Levee			GPS Latitude/Longitude	
				Start	End
Item	Vegetation			39.027172 °	39.028325 °
				-121.821437 °	-121.808907 °
DWR ID	DWR_ST0009_01_f_2018_11				
Comment Code					
V1 : Control annual grass and weeds on the levee slopes and easements.					
Inspector Comment					
The vegetation was removed from the landside slope.

View of the removed vegetation from the landside slope.

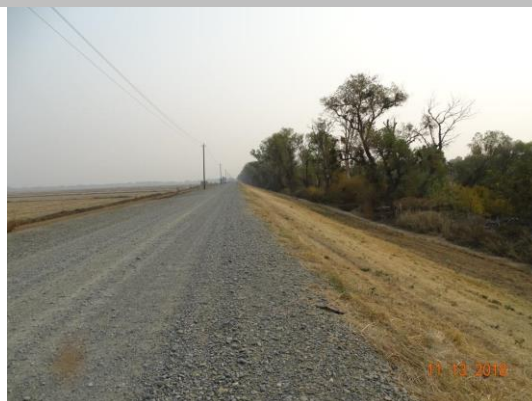
Photo 1 of 2 : FA_2018_ST0009_286_10_20181114_00024.jpg

LM Start	0.02	Rating **	A	Issue No.	10
LM End	4.50	Issue Type +	Ma	Location *	WS
Category	Earthen Levee			GPS Latitude/Longitude	
				Start	End
Item	Vegetation			39.027172 °	39.032885 °
				-121.821437 °	-121.743387 °
DWR ID	DWR_ST0009_01_f_2018_10				
Comment Code					
V2 : Remove the wild growth other than native grasses from the levee slopes.					
Inspector Comment					
The vegetation was mowed or burned along the waterside slope.

View of the mowed or burned vegetation along the waterside slope.

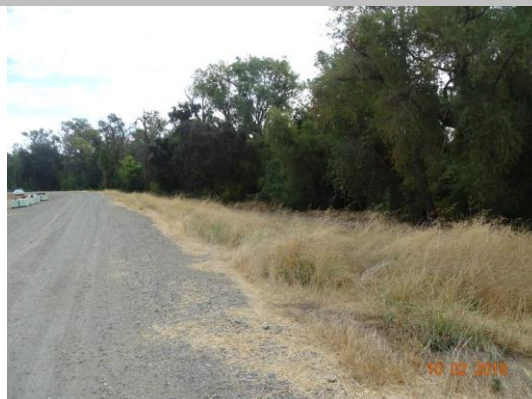
Photo 2 of 2 : FA_2018_ST0009_286_10_20181008_00020.jpg

LM Start	0.02	Rating **	A	Issue No.	10 (cont)
LM End	4.50	Issue Type +	Ma	Location *	WS

View of the vegetation along the waterside slope.

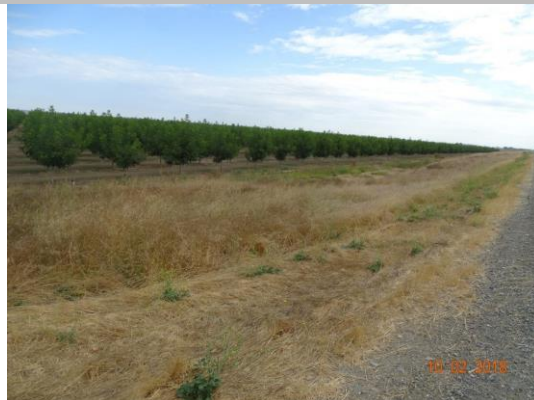
Photo 1 of 1 : FA_2018_ST0009_286_15_20181008_00021.jpg

LM Start	0.71	Rating **	A	Issue No.	15
LM End	1.44	Issue Type +	Ma	Location *	LS
Category	Earthen Levee			GPS Latitude/Longitude	
				Start	End
Item	Vegetation			39.028325 °	39.028257 °
				-121.808907 °	-121.795252 °
DWR ID	DWR_ST0009_01_f_2018_15				
Comment Code					
V2 : Remove the wild growth other than native grasses from the levee slopes.					
Inspector Comment					
The vegetation was mowed or burned along the landside slope.

View of the vegetation along the landside slope.

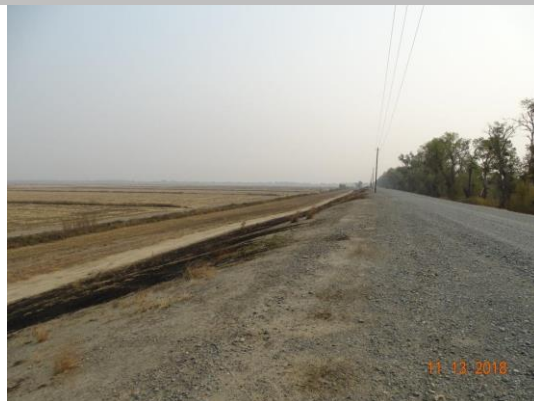
Photo 1 of 2 : FA_2018_ST0009_286_16_20181114_00023.jpg

LM Start	2.00	Rating **	A	Issue No.	16
LM End	4.50	Issue Type +	Ma	Location *	LS
Category	Earthen Levee			GPS Latitude/Longitude	
				Start	End
Item	Vegetation			39.028183 °	39.032885 °
				-121.785020 °	-121.743387 °
DWR ID	DWR_ST0009_01_f_2018_16				
Comment Code					
V2 : Remove the wild growth other than native grasses from the levee slopes.					
Inspector Comment					
The vegetation was burned or mowed along the landside slope.

View of the burned or mowed vegetation along the landside slope.

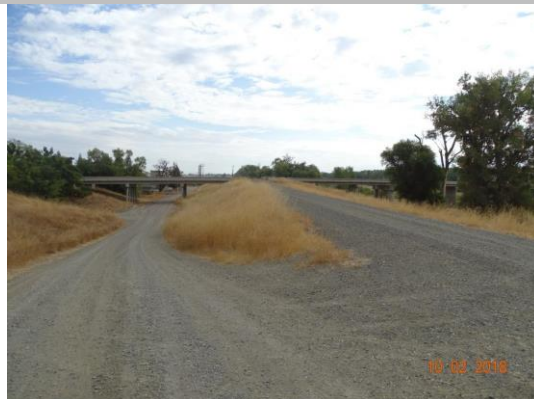
Photo 2 of 2 : FA_2018_ST0009_286_16_20181008_00022.jpg

LM Start	2.00	Rating **	A	Issue No.	16 (cont)
LM End	4.50	Issue Type +	Ma	Location *	LS

View of the vegetation along the landside slope.

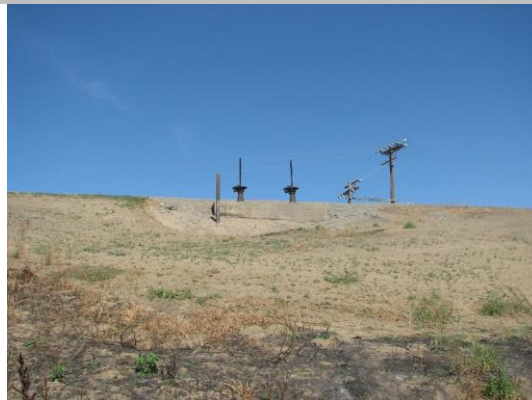
Photo 1 of 3 : UCIP_FA_2018_51484_64226.jpg

Comment Code						
Inspector Comment						
FS_ID:51484 DS_ID:16591 EP_NO: 10099 Repair Type: No Action Needed Crossing Status: Found UCIP Comments: 4/10/2017 Crossing appears to be in good condition. (DWR Sutter Yard- A Freitag)10/11/2016 Crossing appears to be in good conditon.(DWR Sutter Yard - a Freitag)4/18/2016 Crossing appears to be in good condition. No noticeable issues to report.5/7/2015 Crossing is in good condition. No noticeable issues to report.11/13/2014 Same as last inspection.5/12/2014 Same as last inspection.10/30/2013 Same as last inspection.5/20/2013 Same as last inspection. FIELD_STRUCT_DESC: 1 of 2: 4-foot by 7-foot reinforced concrete discharge tunnel through the levee, 38 feet below the crown. Slide gate in 4-foot by 15-foot concrete well on the waterside (WS) slope. Pump house located on the landside (LS) toe and wooden flap gates on the WS toe. (two 4-foot by 7-foot tunnel [HLM 2.13] authorized under Automatic Board Order (ABO) issued as Permit No. 10099, 1955 - Reclamation District No. 1660). [Additional Reference(s): DWR Levee Log, 1993. USACE Sacramento O&M Manual 133, August 1955 (Station 1044+60)]. FS Date: 4/12/2017 9:20:05 AM

Slide gates on WS shoulder.

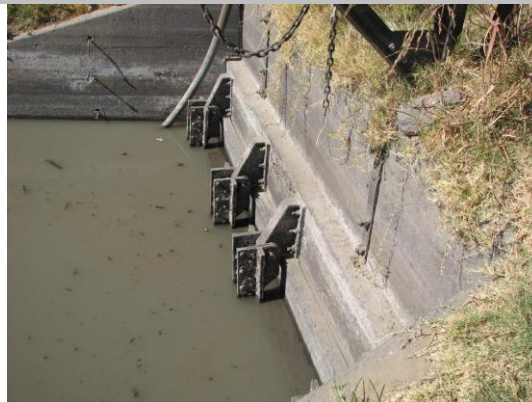
Photo 2 of 3 : UCIP_FA_2018_51484_64225.jpg

Wooden Flap gates on WS toe.

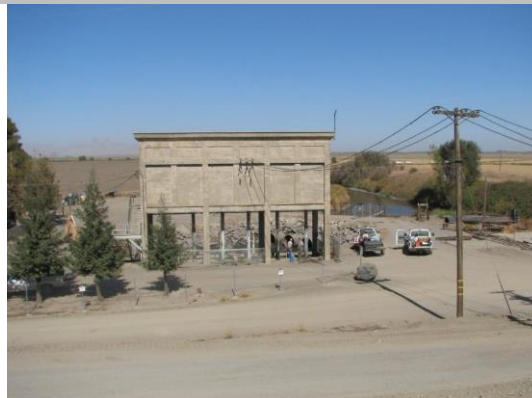
Photo 3 of 3 : UCIP_FA_2018_51484_64224.jpg

Comment Code						
Inspector Comment						
FS_ID:51484 DS_ID:16591 EP_NO: 10099 Repair Type: No Action Needed Crossing Status: Found UCIP Comments: 4/10/2017 Crossing appears to be in good condition. (DWR Sutter Yard- A Freitag)10/11/2016 Crossing appears to be in good conditon.(DWR Sutter Yard - a Freitag)4/18/2016 Crossing appears to be in good condition. No noticeable issues to report.5/7/2015 Crossing is in good condition. No noticeable issues to report.11/13/2014 Same as last inspection.5/12/2014 Same as last inspection.10/30/2013 Same as last inspection.5/20/2013 Same as last inspection. FIELD_STRUCT_DESC: 1 of 2: 4-foot by 7-foot reinforced concrete discharge tunnel through the levee, 38 feet below the crown. Slide gate in 4-foot by 15-foot concrete well on the waterside (WS) slope. Pump house located on the landside (LS) toe and wooden flap gates on the WS toe. (two 4-foot by 7-foot tunnel [HLM 2.13] authorized under Automatic Board Order (ABO) issued as Permit No. 10099, 1955 - Reclamation District No. 1660). [Additional Reference(s): DWR Levee Log, 1993. USACE Sacramento O&M Manual 133, August 1955 (Station 1044+60)]. FS Date: 4/12/2017 9:20:05 AM

Pump house on LS toe.

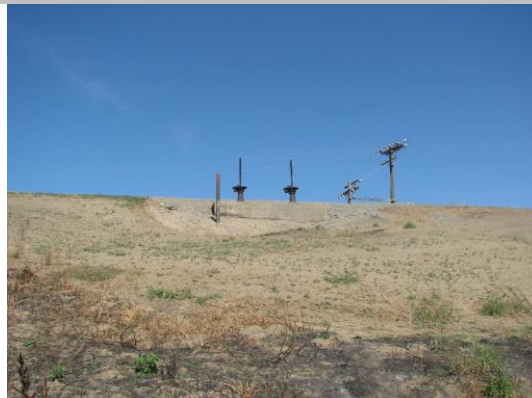
Photo 1 of 3 : UCIP_FA_2018_51485_64230.jpg

Comment Code					
Inspector Comment					
FS_ID:51485 DS_ID:16856 EP_NO: 10099 Repair Type: No Action Needed Crossing Status: Found UCIP Comments: 4/10/2017 Crossing appears to be in good condition. (DWR Sutter Yard- A Freitag)10/11/2016 Crossing appears to be in good condition.(DWR Sutter Yard - a Freitag)4/18/2016 Crossing appears to be in good condition. No noticeable issues to report.5/7/2015 Crossing is in good condition. No noticeable issues to report.11/13/2014 Same as last inspection.5/12/2014 Same as last inspection.10/30/2013 Same as last inspection.5/20/2013 Same as last inspection. FIELD_STRUCT_DESC: 2 of 2: 4-foot by 7-foot concrete discharge tunnel through the levee, 38 feet below the crown. Slide gate in 4-foot by 15-foot concrete well on the waterside (WS) slope. Pump house located on the landside (LS) toe and wooden flap gates on the WS toe. (two 4-foot by 7-foot tunnel [HLM 2.13] authorized under Automatic Board Order (ABO) issued as Permit No. 10099, 1955 - Reclamation District No. 1660). [Additional Reference(s): DWR Levee Log, 1993. USACE Sacramento O&M Manual 133, August 1955 (Station 1044+60)]. FS Date: 4/12/2017 9:20:37 AM

Slide gates on WS shoulder.

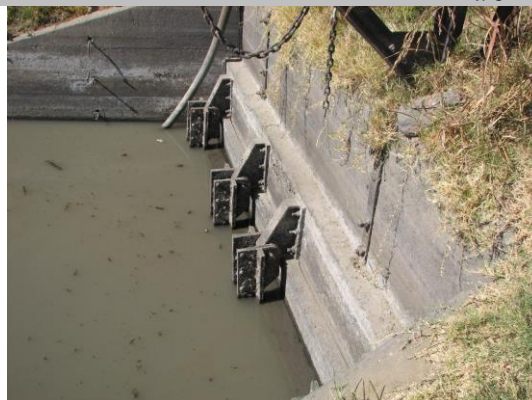
Photo 2 of 3 : UCIP_FA_2018_51485_64229.jpg

Wooden flap gates on WS toe.

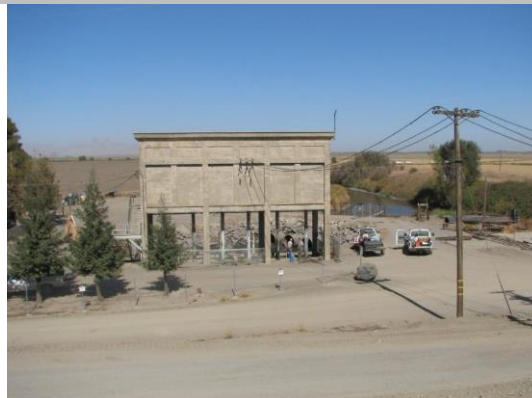
Photo 3 of 3 : UCIP_FA_2018_51485_64228.jpg

Comment Code						
Inspector Comment						
FS_ID:51485 DS_ID:16856 EP_NO: 10099 Repair Type: No Action Needed Crossing Status: Found UCIP Comments: 4/10/2017 Crossing appears to be in good condition. (DWR Sutter Yard- AFreitag)10/11/2016 Crossing appears to be in good condition.(DWR Sutter Yard - afreitag)4/18/2016 Crossing appears to be in good condition. No noticeable issues to report.5/7/2015 Crossing is in good condition. No noticeable issues to report.11/13/2014 Same as last inspection.5/12/2014 Same as last inspection.10/30/2013 Same as last inspection.5/20/2013 Same as last inspection. FIELD_STRUCT_DESC: 2 of 2: 4-foot by 7-foot concrete discharge tunnel through the levee, 38 feet below the crown. Slide gate in 4-foot by 15-foot concrete well on the waterside (WS) slope. Pump house located on the landside (LS) toe and wooden flap gates on the WS toe. (two 4-foot by 7-foot tunnel [HLM 2.13] authorized under Automatic Board Order (ABO) issued as Permit No. 10099, 1955 - Reclamation District No. 1660). [Additional Reference(s): DWR Levee Log, 1993. USACE Sacramento O&M Manual 133, August 1955 (Station 1044+60)]. FS Date: 4/12/2017 9:20:37 AM

Pump house on LS toe.

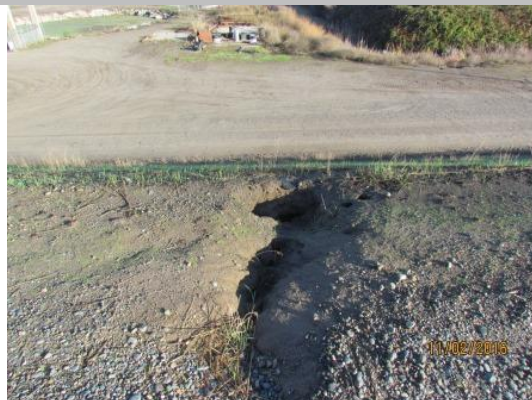
Photo 1 of 2 : FA_2018_ST0009_286_12_20180905_00002.jpg

LM Start	2.16	Rating **	U	Issue No.	12
LM End	2.16	Issue Type +	Ma	Location *	LS
Category	Earthen Levee			GPS Latitude/Longitude	
				Start	End
Item	Animal Control			39.028137°	39.028137°
				-121.782020°	-121.782020°
DWR ID	DWR_ST0009_01_f_2016_12				
Comment Code					
A3 : No rodents visible, but rodent burrows visible; need to backfill and compact or grout burrows.					
Inspector Comment

View of a rodent hole along the levee crown.

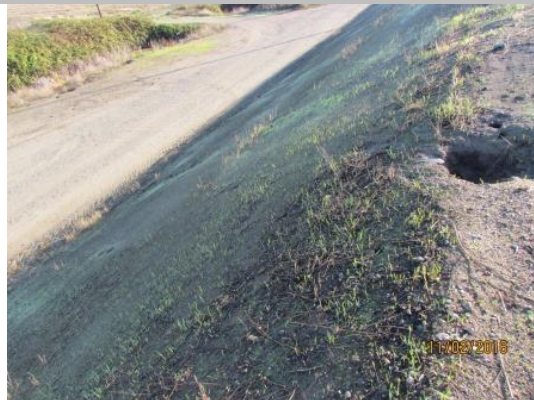
Photo 2 of 2 : FA_2018_ST0009_286_12_20180905_00003.jpg

LM Start	2.16	Rating **	U	Issue No.	12 (cont)
LM End	2.16	Issue Type +	Ma	Location *	LS
Category	Earthen Levee			GPS Latitude/Longitude	
				Start	End
Item	Animal Control			39.028137°	39.028137°
				-121.782020°	-121.782020°
DWR ID	DWR_ST0009_01_f_2016_12				
Comment Code					
A3 : No rodents visible, but rodent burrows visible; need to backfill and compact or grout burrows.					
Inspector Comment

Another view of the rodent holes along the crown and landside slope.

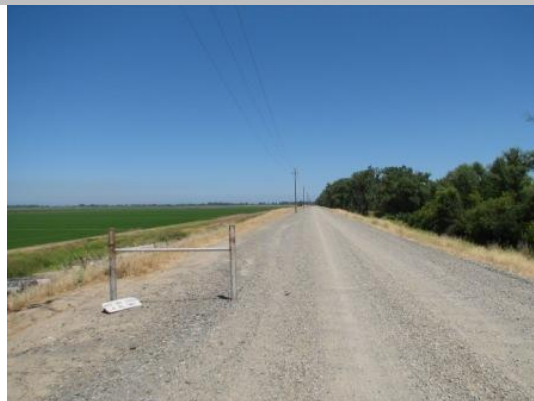
Photo 1 of 1 : FA_2018_ST0009_286_3_20180905_00001.jpg

LM Start	2.19	Rating **	M	Issue No.	3
LM End	4.11	Issue Type +	En	Location *	LS
Category	Earthen Levee			GPS Latitude/Longitude	
				Start	End
Item	Encroachments			39.028173 °	39.028012 °
				-121.781475 °	-121.745665 °
DWR ID	DWR_ST0009_01_s _ 2012_3				
Comment Code					
PO : Pole					
Inspector Comment

View of the PG&E poles along the landside crown of the levee.

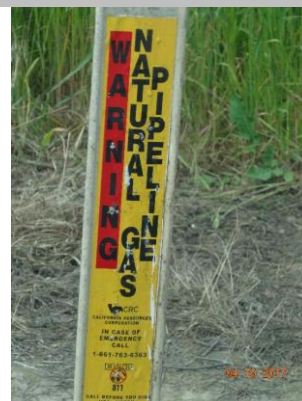
Photo 1 of 2 : UCIP_FA_2018_51486_76941.jpg

Comment Code						
Inspector Comment						
FS_ID:51486 DS_ID:16590 EP_NO: 14740 Repair Type: Non-Urgent Crossing Status: Indicator Found UCIP Comments: 4/10/2017 Carsonite marker on WS missing. (DWR Sutter Yard- AFreitag)10/11/2016 Carsontie marker on WS shoulder is still missing.(DWR Sutter Yard - afreitag)4/18/2016 Carsonite marker on WS shoulder is missing.5/7/2015 Marker on WS shoulder missing.11/13/2014 Same as last inspection.5/12/2014 Same as last inspection.10/30/2013 Same as last inspection.5/20/2013 Carsonite marker on WS shoulder missing and should be replaced. FIELD_STRUCT_DESC: 4-inch steel gas pipeline through the levee and under channel, 2.5 feet below the crown. Carsonite signs on both the landside (LS) and the waterside (WS) shoulders. Gas wells 200 feet off of the LS toe. (Permit No. 14740, 1988 - Nahama and Weagant Energy Co.) [Additional Reference(s): DWR Levee Log, 1993]. FS Date: 4/12/2017 9:21:13 AM

Close up of LS marker

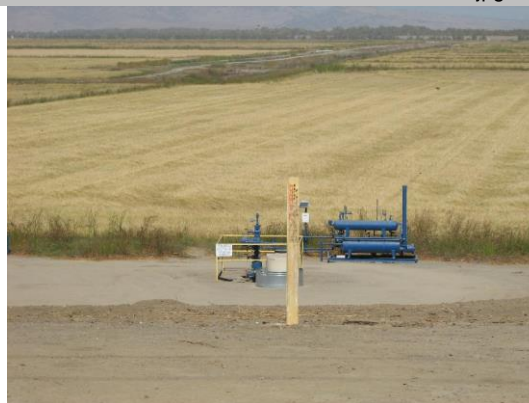
Photo 2 of 2 : UCIP_FA_2018_51486_64220.jpg

Carsonite sign on LS shoulder with view of gas well in background.

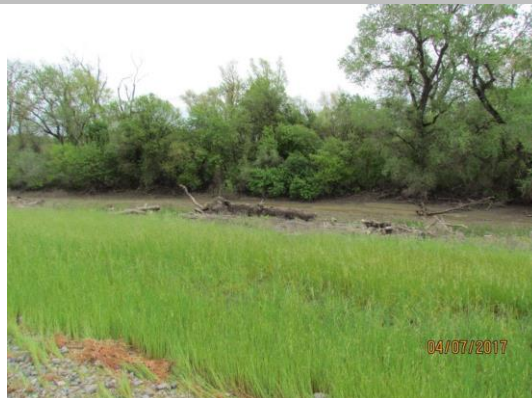
Photo 1 of 1 : FA_2018_ST0009_286_24_20180905_00004.jpg

View of the debris along the waterside slope and toe.

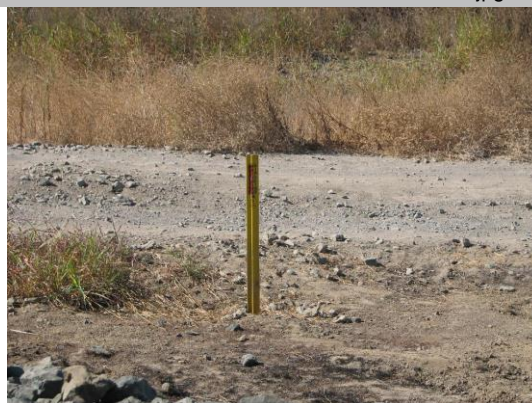
Photo 1 of 3 : UCIP_FA_2018_51487_64235.jpg

Comment Code					
Inspector Comment					
FS_ID:51487 DS_ID:16855 EP_NO: 14455 Repair Type: Non-Urgent Crossing Status: Indicator Found UCIP Comments: 4/10/2017 LS marker still broken and there is no marker on the WS. (DWR Sutter Yard- AFreitag)10/11/2016 LS carsonite marker is still broken.(DWR Sutter Yard - afreitag)4/18/2016 Carsonite marker on LS slope is broke off.5/7/2015 Crossing is in good condition. No noticeable issues to report.11/13/2014 Same as last inspection.5/12/2014 Same as last inspection.10/30/2013 Same as last inspection.5/20/2013 Same as last inspection. FIELD_STRUCT_DESC: 1 of 2: 4.5-inch steel natural gas pipeline through the levee, 2 feet below the crown. Line goes across the Sutter Bypass and through both levees. Carsonite sign on the landside (LS) slope. Drawings are available. (Permit No. 14455, 1986 - Depco Inc.). [Additional Reference(s): DWR Levee Log, 1993]. FS Date: 4/12/2017 9:22:54 AM

Carsonite sign on LS slope.

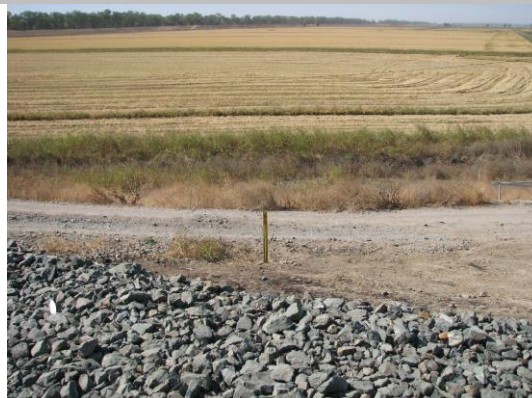
Photo 2 of 3 : UCIP_FA_2018_51487_64234.jpg

Comment Code						
Inspector Comment						
FS_ID:51487 DS_ID:16855 EP_NO: 14455 Repair Type: Non-Urgent Crossing Status: Indicator Found UCIP Comments: 4/10/2017 LS marker still broken and there is no marker on the WS. (DWR Sutter Yard- AFreitag)10/11/2016 LS carsonite marker is still broken.(DWR Sutter Yard - afreitag)4/18/2016 Carsonite marker on LS slope is broke off.5/7/2015 Crossing is in good condition. No noticeable issues to report.11/13/2014 Same as last inspection.5/12/2014 Same as last inspection.10/30/2013 Same as last inspection.5/20/2013 Same as last inspection. FIELD_STRUCT_DESC: 1 of 2: 4.5-inch steel natural gas pipeline through the levee, 2 feet below the crown. Line goes across the Sutter Bypass and through both levees. Carsonite sign on the landside (LS) slope. Drawings are available. (Permit No. 14455, 1986 - Depco Inc.). [Additional Reference(s): DWR Levee Log, 1993]. FS Date: 4/12/2017 9:22:54 AM

Carsonite sign on LS slope.

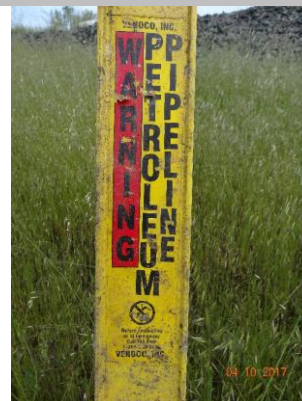
Photo 3 of 3 : UCIP_FA_2018_51487_76942.jpg

Close up of LS marker

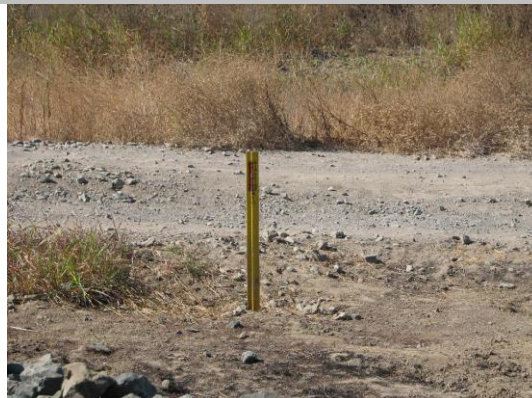
Photo 1 of 3 : UCIP_FA_2018_51488_64233.jpg

Comment Code						
Inspector Comment						
FS_ID:51488 DS_ID:16589 EP_NO: 14455 Repair Type: Non-Urgent Crossing Status: Indicator Found UCIP Comments: 4/10/2017 LS marker still broken and there is no marker on the WS. (DWR Sutter Yard- AFreitag)10/11/2016 Carsonite marker on the LS is still broken.(DWR Sutter Yard - afreitag)4/18/2016 Carsonite marker on LS slope is broken off.5/7/2015 Crossing is in good condition. No noticeable issues to report.11/13/2014 Same as last inspection.5/12/2014 Same as last inspection.10/30/2013 Same as last inspection.5/20/2013 Same as last inspection. FIELD_STRUCT_DESC: 2 of 2: 4.5-inch steel natural gas pipeline through the levee, 2 feet below the crown. Line goes across the Sutter Bypass and through both levees. Carsonite sign located on the landside (LS) slope. (Permit No. 14455, 1986 - Depco Inc.). [Additional Reference(s): DWR Levee Log, 1993]. FS Date: 4/12/2017 9:24:35 AM

Carsonite sign on LS slope.

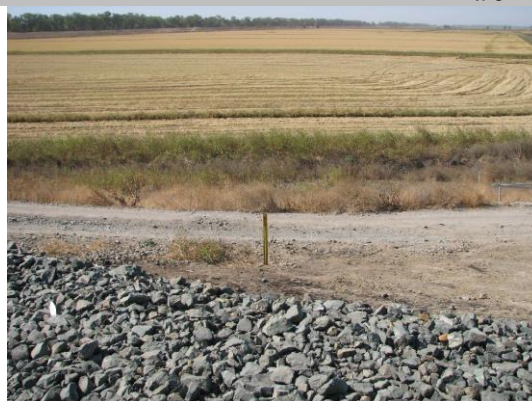
Photo 2 of 3 : UCIP_FA_2018_51488_64232.jpg

Carsonite sign on LS slope.

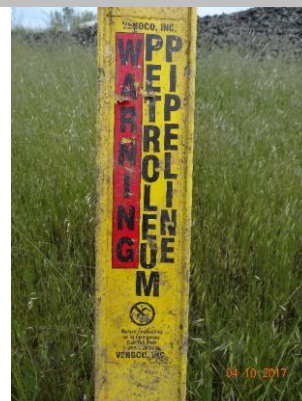
Photo 3 of 3 : UCIP_FA_2018_51488_76943.jpg

Comment Code						
Inspector Comment						
FS_ID:51488 DS_ID:16589 EP_NO: 14455 Repair Type: Non-Urgent Crossing Status: Indicator Found UCIP Comments: 4/10/2017 LS marker still broken and there is no marker on the WS. (DWR Sutter Yard- AFreitag)10/11/2016 Carsonite marker on the LS is still broken.(DWR Sutter Yard - aFreitag)4/18/2016 Carsonite marker on LS slope is broken off.5/7/2015 Crossing is in good condition. No noticeable issues to report.11/13/2014 Same as last inspection.5/12/2014 Same as last inspection.10/30/2013 Same as last inspection.5/20/2013 Same as last inspection. FIELD_STRUCT_DESC: 2 of 2: 4.5-inch steel natural gas pipeline through the levee, 2 feet below the crown. Line goes across the Sutter Bypass and through both levees. Carsonite sign located on the landside (LS) slope. (Permit No. 14455, 1986 - Depco Inc.). [Additional Reference(s): DWR Levee Log, 1993]. FS Date: 4/12/2017 9:24:35 AM

Close up of LS marker

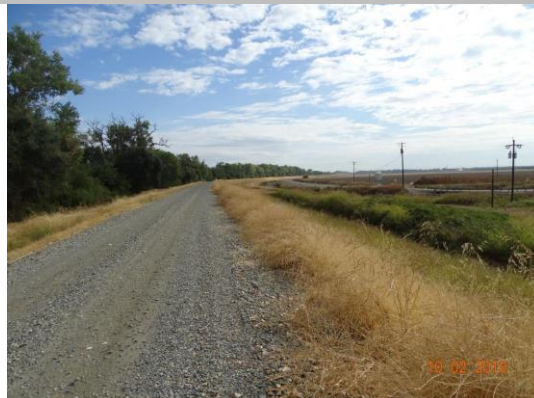
Photo 2 of 2 : FA_2018_ST0009_287_8_20181008_00017.jpg

View of the vegetation along the landside slope.

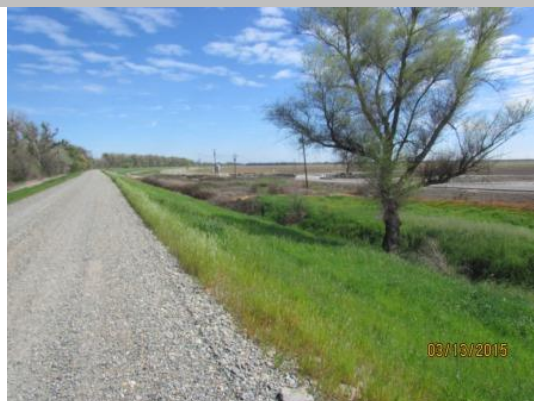
Photo 1 of 1 : FA_2018_ST0009_287_1_20180905_00001.jpg

LM Start	0.11	Rating **	M	Issue No.	1
LM End	0.26	Issue Type +	En	Location *	LS
Category	Earthen Levee			GPS Latitude/Longitude	
				Start	End
Item	Encroachments			39.023760 °	39.024559 °
				-121.818875 °	-121.816344 °
DWR ID	DWR_ST0009_02_s _ 2012_1				
Comment Code					
DT : Ditch					
Inspector Comment					
Monitor the ditch for erosion.

View of the agricultural ditch along the landside toe.

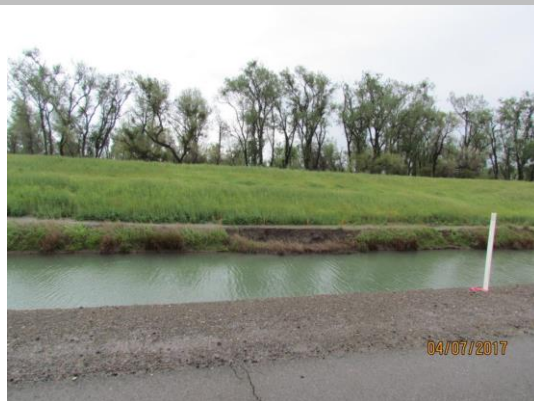
Photo 1 of 1 : FA_2018_ST0009_287_9_20180905_00005.jpg

LM Start	0.69	Rating **	M	Issue No.	9
LM End	0.71	Issue Type +	Ma	Location *	LS
Category	Earthen Levee			GPS Latitude/Longitude	
				Start	End
Item	Erosion / Bank Caving			39.025602 °	39.025657 °
				-121.808527 °	-121.808027 °
DWR ID	DWR_ST0009_02_s_2017_9				
Comment Code					
E2 : Schedule repair of erosion site prior to the next inspection.					
Inspector Comment					
Repair the erosion along the landside toe.

View of the erosion along the landside toe from the County Road.

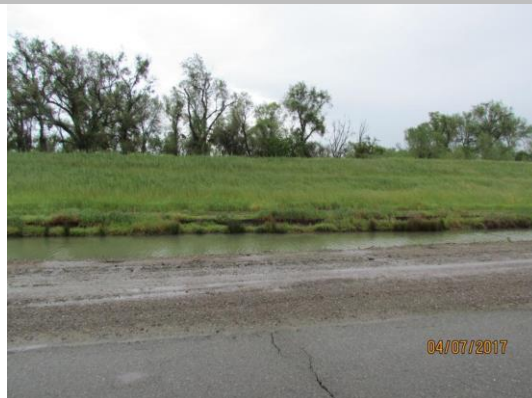
Photo 1 of 1 : FA_2018_ST0009_287_10_20180905_00006.jpg

LM Start	0.97	Rating **	M	Issue No.	10
LM End	0.98	Issue Type +	Ma	Location *	LS
Category	Earthen Levee			GPS Latitude/Longitude	
				Start	End
Item	Erosion / Bank Caving			39.025540 °	39.025572 °
				-121.803272 °	-121.802990 °
DWR ID	DWR_ST0009_02_s_2017_10				
Comment Code					
E2 : Schedule repair of erosion site prior to the next inspection.					
Inspector Comment					
Repair the erosion along the landside toe.

View of the erosion along the landside toe from the County Road.

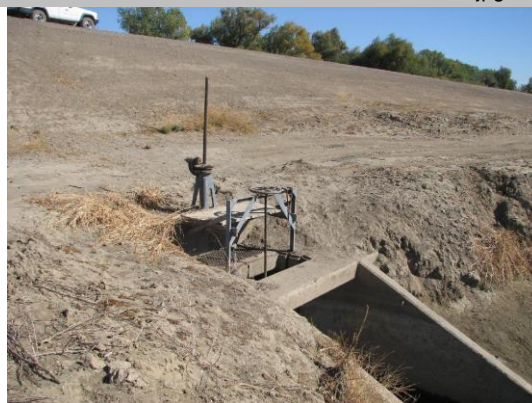
Photo 1 of 3 : UCIP_FA_2018_53047_64675.jpg

Comment Code						
Inspector Comment						
FS_ID:53047 DS_ID:16594 EP_NO: 267 Repair Type: Urgent Crossing Status: Found UCIP Comments: 10/4/2018 Erosion around WS vault is progressing. Recommended FSRP evaluation of this site. Dense vegetation around the site. Crossing remains "Urgent" due to the erosion observed on WS. (O.Yakimov - DWR)4/10/2017 Erosion appears to be getting worse at the WS vault. It is starting to erode away the WS toe road. (DWR Sutter Yard- A.Freitag)10/11/2016 Erosion still present behind the WS vault.(DWR Sutter Yard - a.freitag)4/18/2016 Erosion happening around the WS concrete vault.5/7/2015 Burrowing near WS toe stil present.11/13/2014 Same as last inspection.5/12/2014 Same as last inspection.10/30/2013 Same as last inspection.5/20/2013 Same as last inspection.10/17/2012 Burrowing along downstream side of concrete vault on WS Toe. May need to be grouted. FIELD_STRUCT_DESC: 54-inch reinforced concrete irrigation pipe through the levee, 29.5 feet below the crown. Slide gates on both the waterside (WS) and the landside (LS) ends. WS end gate in 5-foot by 6-foot concrete box. LS end gate in concrete ""U"" shaped headwall. Concrete encased steel siphon pipe under and across bypass. (Permit Nos. 267 and 290 - Sutter Basin Improvement Co. [dates unknown]). [Additional Reference(s): DWR Levee Log, 1993. USACE Sacramento O&M Manual 129, August 1955 (Station 61+25)]. FS Date: 10/4/2018 1:10:58 PM

Slide gate at concrete outlet on LS toe.

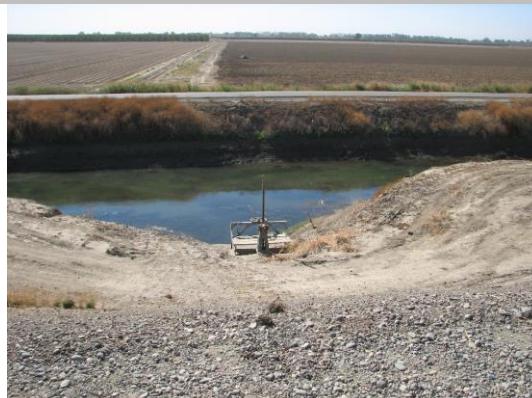
Photo 2 of 3 : UCIP_FA_2018_53047_64674.jpg

FS_ID:53047
DS_ID:16594
EP_NO: 267
Repair Type: Urgent
Crossing Status: Found
UCIP Comments: 10/4/2018 Erosion around WS vault is progressing. Recommended FSRP evaluation of this site. Dense vegetation around the site. Crossing remains "Urgent" due to the erosion observed on WS. (O.Yakimov - DWR)4/10/2017 Erosion appears to be getting worse at the WS vault. It is starting to erode away the WS toe road. (DWR Sutter Yard- AFreitag)10/11/2016 Erosion still present behind the WS vault.(DWR Sutter Yard - afreitag)4/18/2016 Erosion happening around the WS concrete vault.5/7/2015 Burrowing near WS toe stil present.11/13/2014 Same as last inspection.5/12/2014 Same as last inspection.10/30/2013 Same as last inspection.5/20/2013 Same as last inspection.10/17/2012 Burrowing along downstream side of concrete vault on WS Toe. May need to be grouted.
FIELD_STRUCT_DESC: 54-inch reinforced concrete irrigation pipe through the levee, 29.5 feet below the crown. Slide gates on both the waterside (WS) and the landside (LS) ends. WS end gate in 5-foot by 6-foot concrete box. LS end gate in concrete ""U"" shaped headwall. Concrete encased steel siphon pipe under and across bypass. (Permit Nos. 267 and 290 - Sutter Basin Improvement Co. [dates unknown]).

Slide gate at concrete outlet on LS toe.

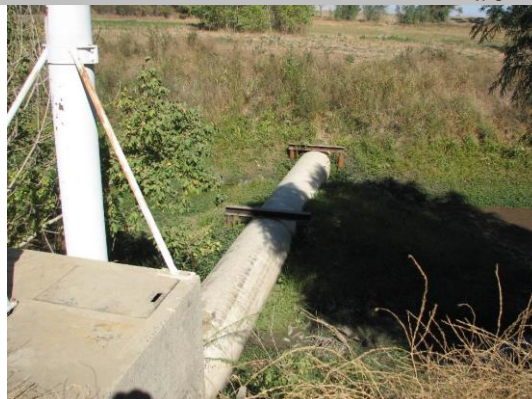
Photo 3 of 3 : UCIP_FA_2018_53047_64673.jpg

Concrete box, vent, and 54-inch steel pipe in WS toe.

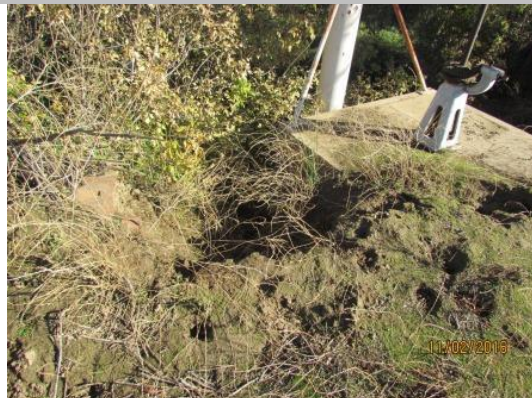
Photo 1 of 2 : FA_2018_ST0009_287_13_20180905_00007.jpg

LM Start	1.14	Rating **	M	Issue No.	13
LM End	1.14	Issue Type +	Ma	Location *	WS
Category	Earthen Levee			GPS Latitude/Longitude	
				Start	End
Item	Erosion / Bank Caving			39.025460 °	39.025460 °
				-121.800022 °	-121.800022 °
DWR ID	DWR_ST0009_02_f_2016_13				
Comment Code					
E2 : Schedule repair of erosion site prior to the next inspection.					
Inspector Comment					
Erosion around the WS concrete vault.

View of the erosion along the concrete vault.

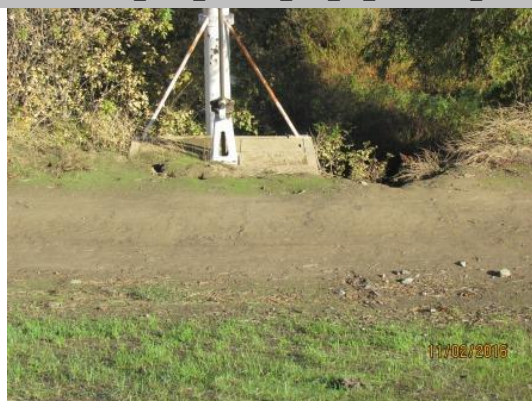
Photo 2 of 2 : FA_2018_ST0009_287_13_20180905_00008.jpg

LM Start	1.14	Rating **	M	Issue No.	13 (cont)
LM End	1.14	Issue Type +	Ma	Location *	WS

Another view of the erosion along the concrete vault.

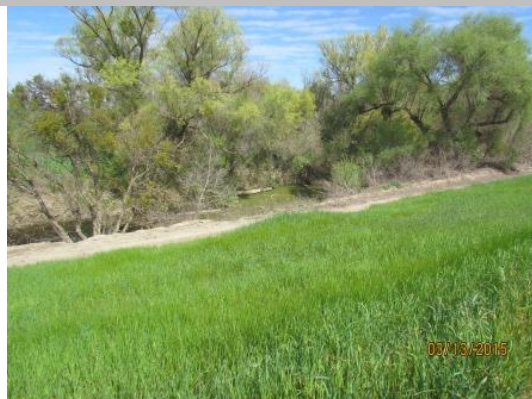
Photo 1 of 1 : FA_2018_ST0009_287_290_20180905_00010.jpg

LM Start	1.19	Rating **	A/W	Issue No.	290
LM End	1.19	Issue Type +	Ma	Location *	WS
Category	Earthen Levee			GPS Latitude/Longitude	
				Start	End
Item	Erosion / Bank Caving			39.025490 °	39.025490 °
				-121.799240 °	-121.799240 °
DWR ID	DWR_ST0009_02_s_2015_290				
Comment Code					
E1 : Note and monitor erosion site.					
Inspector Comment					
Sutter Yard needs to monitor the erosion along the berm.

View of the erosion along the waterside berm.

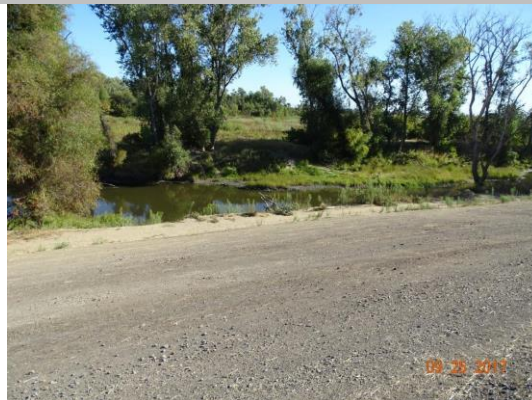
Photo 1 of 1 : FA_2018_ST0009_287_18_20180905_00009.jpg

LM Start	4.09	Rating **	A/W	Issue No.	18
LM End	4.09	Issue Type +	Ma	Location *	WS
Category	Earthen Levee			GPS Latitude/Longitude	
				Start	End
Item	Erosion / Bank Caving			39.024912 °	39.024912 °
				-121.745237 °	-121.745237 °
DWR ID	DWR_ST0009_02_f_2017_18				
Comment Code					
E2 : Schedule repair of erosion site prior to the next inspection.					
Inspector Comment					
Repair the erosion along the water side berm.

View of the erosion along the waterside berm.

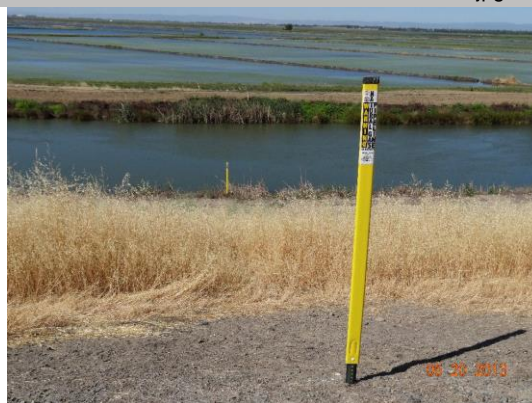
Photo 1 of 3 : UCIP_FA_2018_51491_64681.jpg

Comment Code					
Inspector Comment					
FS_ID:51491 DS_ID:23099 EP_NO: N/A Repair Type: Non-Urgent Crossing Status: Found UCIP Comments: 4/10/2017 Crossing appears to be in good condition. (DWR Sutter Yard- AFreitag)10/11/2016 Crossing appears to be in good condition but there is no permit on file. Photos of the markers were uploaded on 5/20/2013.(DWR Sutter Yard - afreitag)5/3/2016 Need photos of markers on both WS and LS. 4/18/2016 Crossing appears to be in good condition. No noticeable issues to report.5/7/2015 Crossing is in good condition. No noticeable issues to report.11/13/2014 Same as last inspection.5/12/2014 Same as last inspection.10/30/2013 Same as last inspection.10/17/2012 Need to identify permit for crossing. FIELD_STRUCT_DESC: Steel natural gas pipeline of an unknown size through the levee, at an unknown depth. Markers visible on the landside (LS) shoulder and toe and the waterside (WS) shoulder and toe. No permit has been identified since the crossing was field discovered in 2012. FS Date: 4/12/2017 9:30:05 AM

Marker on LS shoulder and toe

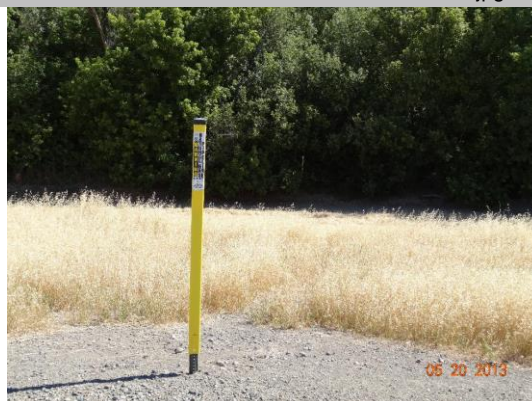
Photo 2 of 3 : UCIP_FA_2018_51491_64680.jpg

FS_ID:51491
DS_ID:23099
EP_NO: N/A
Repair Type: Non-Urgent
Crossing Status: Found
UCIP Comments: 4/10/2017 Crossing appears to be in good condition. (DWR Sutter Yard- AFreitag)10/11/2016 Crossing appears to be in good condition but there is no permit on file. Photos of the markers were uploaded on 5/20/2013.(DWR Sutter Yard - afreitag)5/3/2016 Need photos of markers on both WS and LS. 4/18/2016 Crossing appears to be in good condition. No noticeable issues to report.5/7/2015 Crossing is in good condition. No noticeable issues to report.11/13/2014 Same as last inspection.5/12/2014 Same as last inspection.10/30/2013 Same as last inspection.10/17/2012 Need to identify permit for crossing.
FIELD_STRUCT_DESC: Steel natural gas pipeline of an unknown size through the levee, at an unknown depth. Markers visible on the landside (LS) shoulder and toe and the waterside (WS) shoulder and toe. No permit has been identified since the crossing was field discovered in 2012.

Marker on WS shoulder

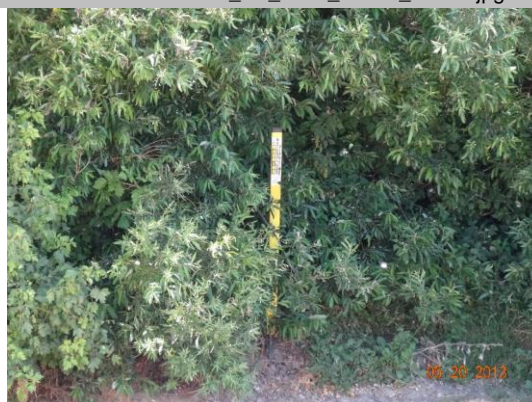
Photo 3 of 3 : UCIP_FA_2018_51491_64679.jpg

Marker on WS toe
